# Sugarloaf Ridge State Park 2017-2018 Financial & Operations Report

#### REPORT ON SUGARLOAF RIDGE STATE PARK RECONSTRUCTION

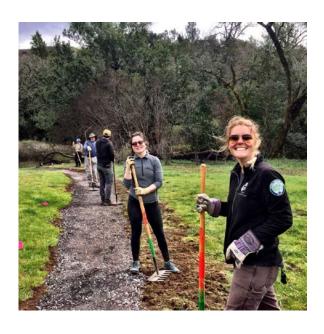
### Trail Work

Also, we rebuilt about 1 mile of trail. Hillside Trail, Lower Bald Mt. Trail, Pony Gate Trail, and Brushy Peaks Trail all had sections that required rebuilding after fire breaks were bulldozed along and through the trails. Cal Fire repaired roads, but not trails after the fire. The repairs required a combination of regrading, ditching, laying gravel, edging and finishing.
